# Importance of Advanced Imaging in Suspected Stress Fractures

Ballarat Veterinary Practice Equine Clinic,  
Miners Rest, Victoria

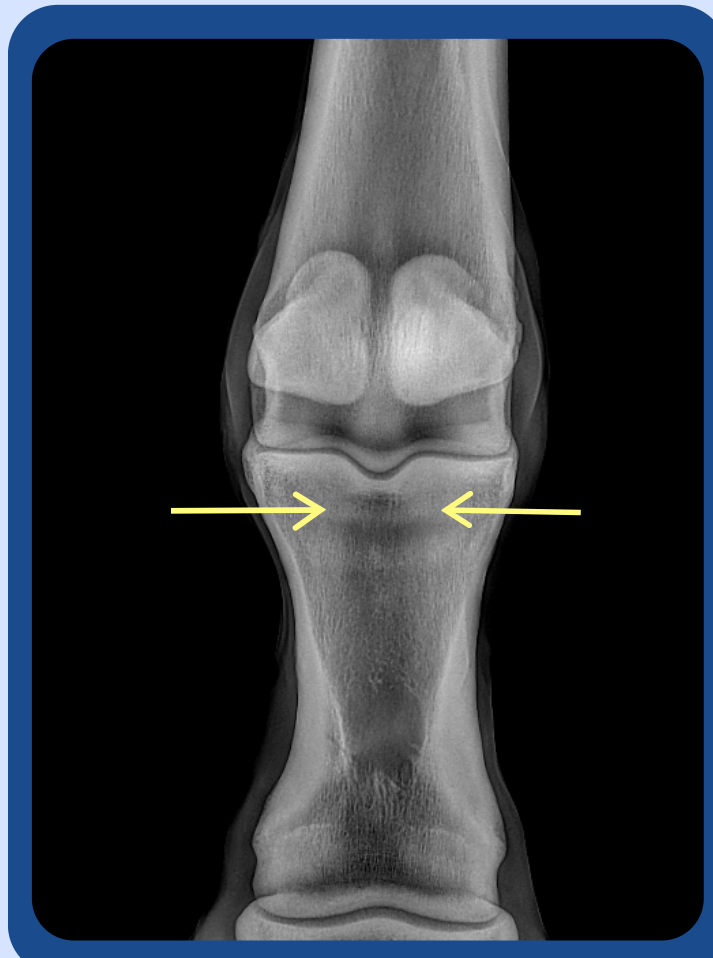
Xrays showed no obvious evidence of a fracture within P1, however mild lucency can be detected in the mid sagittal region (Fig 1).

Figure 1: Initial radiographs showing mild lucency in the mid sagittal region.

Initial radiographs were unremarkable, demonstrating the limitations of radiography in detecting early stress-related bone injury. Although CT is considered the gold standard for fracture imaging and surgical planning, only MRI and scintigraphy were available in this case. MRI was selected over scintigraphy because of its superior anatomical localisation and ability to detect internal bone pathology. It identified bone marrow oedema, trabecular injury, and early stress-related changes associated with an incomplete P1 fracture<sup>2</sup>, while also defining fracture orientation to guide surgical planning and screw placement<sup>4</sup>. Although scintigraphy may have detected increased bone activity, it would not have accurately characterised the fracture lines.

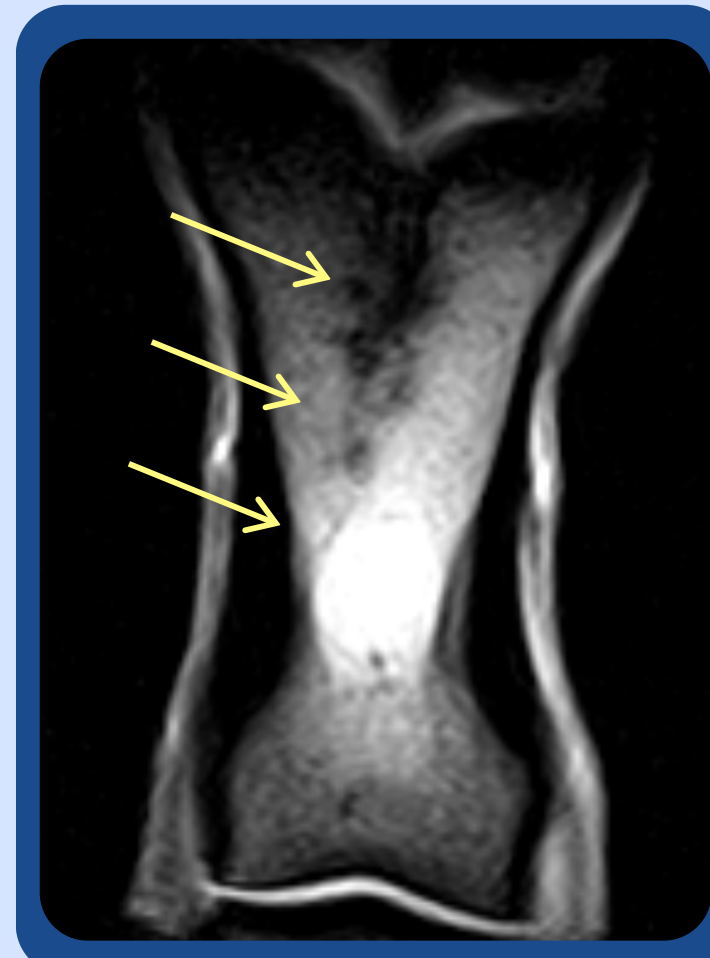
Figure 2: T2\*W GRE FRO FAST - L Trabecular bone damage consistent with a chronic incomplete sagittal plane stress fracture of P1.

Standing MRI evaluation showed trabecular bone damage consistent with chronic incomplete sagittal P1 fracture (Fig 2 & 4).

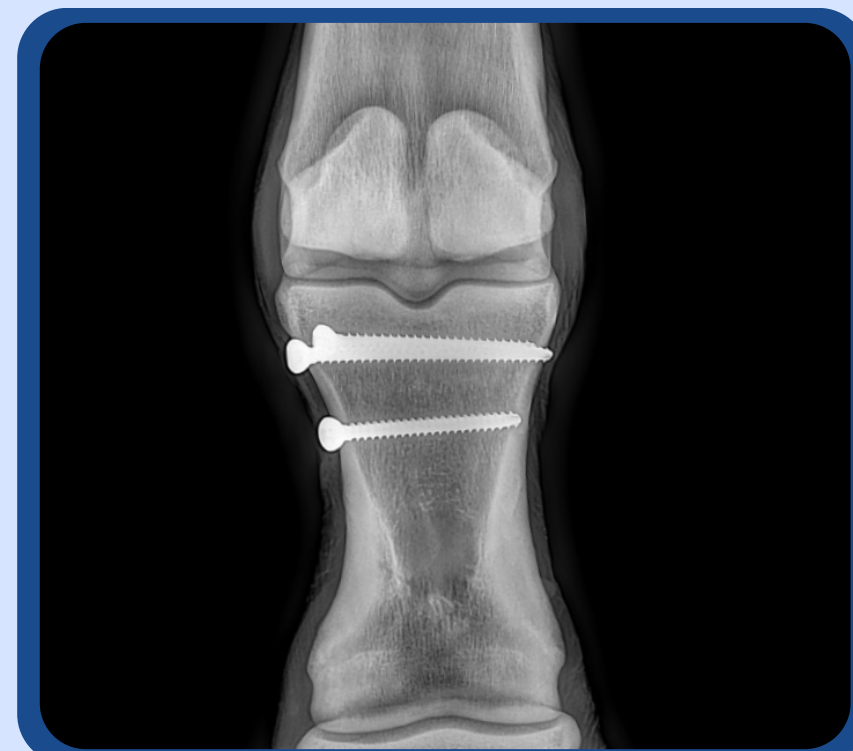
Figure 3: Post-surgery radiographs confirming placement of lag screws.

- Surgical repair was performed under general anaesthesia. Three cortical screws were placed in lag fashion perpendicular to the fracture plane based off MRI findings.
- Radiographic monitoring confirmed appropriate screw placement (Fig 3).
- A fiberglass cast was applied for recovery and removed the following day.
